Flight Test of Takeoff Performance Monitoring System

David B. Middleton Langley Research Center • Hampton, Virginia

The Takeoff Performance Monitoring System (TOPMS) has been developed at the Langley Research Center and flight tested on the Transport System Research Vehicle (TSRV), a highly modified Boeing 737-100 research airplane. The TOPMS is a computer software and hardware graphics system that visually displays current runway position, acceleration performance, engine status, and other situation advisory information to aid pilots in their decision to continue or to abort a takeoff. A total of 55 takeoff and 30 abort situations were investigated at five airfields. The TOPMS was tested for various nominal and off-nominal conditions, including normal takeoffs; reduced-throttle takeoffs; inducedacceleration deficiencies; simulated-engine failures; and several gross-weight, runway-geometry, runwaysurface, and ambient conditions. All tests were made on dry runways.

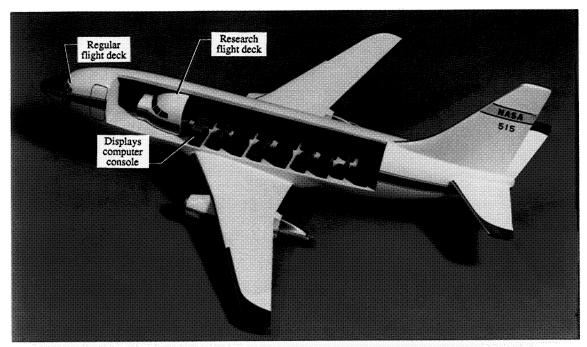
L-80-2580

Figure 1. Cutaway view of TSRV B-737-100.

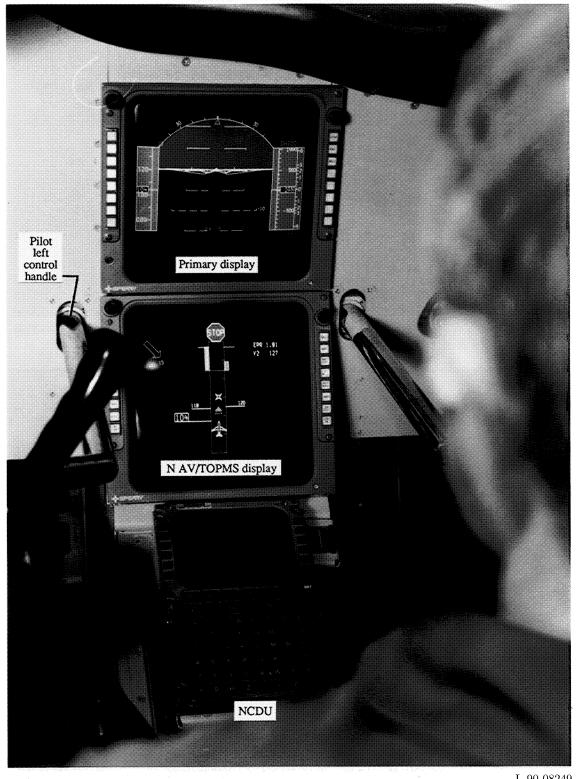
L-90-08249

Figure 3. Displays in front of TOPMS Pilot.

If an engine were to fail before the airplane reaches V_1 (during an otherwise normal takeoff situation), it would produce a head-down TOPMS display similar to the one shown in figure 3. In this instance, the right engine has failed at approximately 100 knots and the display is conveying an abort SAF

(STOP sign) to the pilot. Additionally, the algorithm has determined that for an immediate abort and use of maximum braking, the airplane can be stopped at the \times shown about halfway down the 6000-ft runway.

- 8. Engine failures were simulated when the Safety Pilot appropriately moved one throttle to artificially induce an EPR discrepancy. For this test only, the algorithm compared the EPR value associated with the current deflected throttle position and its initial target value. Such failures were detected by the TOPMS Pilot as a shrinking red EPR bar and an accompanying abort SAF. (See fig. 3.)

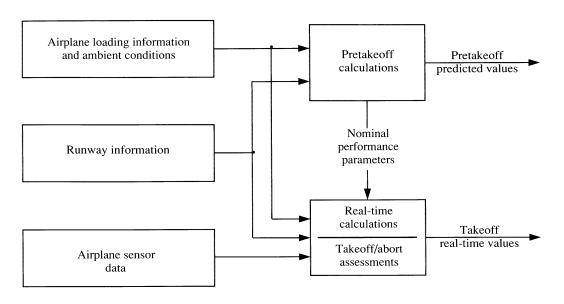
Figure 4. Functions of TOPMS algorithm.

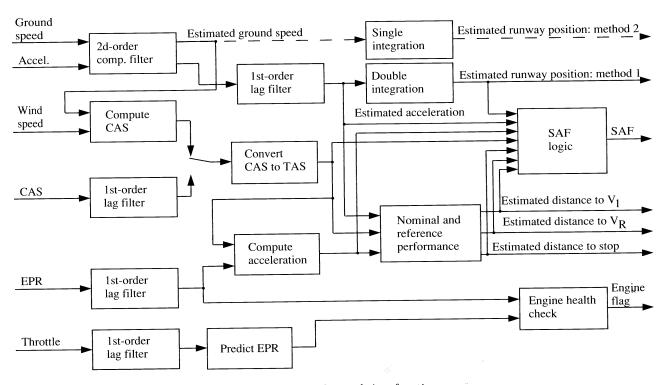
The functions performed by most of the blocks are self-explanatory; the measured inputs enter from the left and the computer-estimated outputs emerge at the right. At low speeds, the algorithm uses measured ground speed and wind to compute airspeed; then at approximately 40 knots, the airplane real-time-computed airspeed becomes valid and replaces airspeed derived from integrated ground speed by

Figure 7. Algorithm real-time functions.

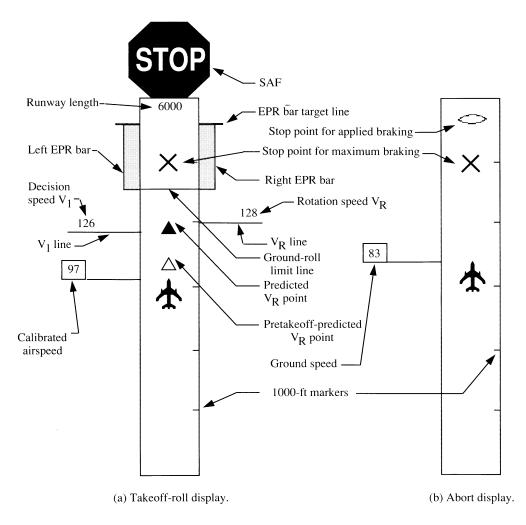
The takeoff-roll situation illustrated in figure 8(a) shows the airplane about halfway down a 6000-ft runway traveling at a CAS of 97 knots (displayed in the box left of the airplane symbol). Pretakeoff computations for this case were based on nominal acceleration and the algorithm predicted that a decision speed V_1 of 126 knots and a rotation speed V_R of 128 knots could be achieved near the unshaded triangle. However, during the takeoff roll, actual acceleration was considerably below nominal, which caused the horizontal V_1 and V_R lines and the shaded triangle to move forward. Specifically, the position of the V_R line corresponds to the computed alongtrack position of the shaded triangle apex. This forward movement of the shaded triangle is an indirect but, nevertheless, an important indication of the acceleration deficiency.

For the situation illustrated in figure 8(a), the ground and air distance beyond V_R is subtracted from total runway length (6000 ft) to establish the location of the GRLL. Note that a takeoff-roll safety margin of approximately 500 ft is evident between the apex of the shaded triangle (viz., the V_R line) and the

Figure 8. TOPMS takeoff-roll and abort-display symbology.

Figure 8(b) shows the TOPMS display after an abort has been initiated. All takeoff-related information has been removed from the runway graphic except the airplane symbol, which shows position on the runway; ground speed, which replaces CAS in the speed box; and the \times , which locates the maximumbraking stop point. An additional symbol, shaped like a football, has appeared that denotes the predicted stop point based on the measured acceleration. Less than maximum braking is required whenever the football position is ahead of the \times .

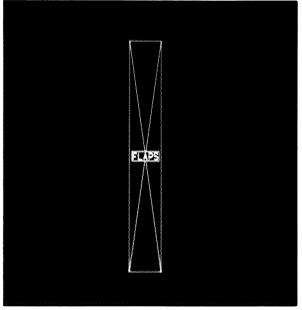
L-92-02984

If the positions of the flaps do not agree with the nominal position specified for the pretakeoff calculations, the partially generated TOPMS display shown in figure 9 will appear on the screen. No additional TOPMS graphics are generated until the flap lever is put in the proper detent and the flaps move to the commanded position.

Figure 9. TOPMS display with flaps in wrong position.

In addition to the test situations listed in table IV, incorrect and inconsistent data were intentionally entered for the pretakeoff calculations to demonstrate that the algorithm was configured to detect unscheduled flap settings, out-of-range or inconsistent inputted data, and runway lengths that were less than the minimum required for the takeoff. Erroneous data were purposely entered at the beginning of each test day; the resulting TOPMS displays (figs. 9 and 10) were observed several times by the TOPMS Pilot.

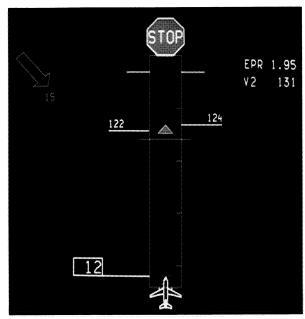
L-92-02985

If the length of the assigned runway is shorter than the minimum distance determined by the algorithm, a TOPMS display similar to the one in figure 10 will appear. Note that the apex of the V_R triangle is well beyond the GRLL (horizontal line across the runway symbol), which causes a STOP sign to appear that advises the pilot not to start the takeoff roll.

Figure 10. TOPMS display when assigned runway too short.

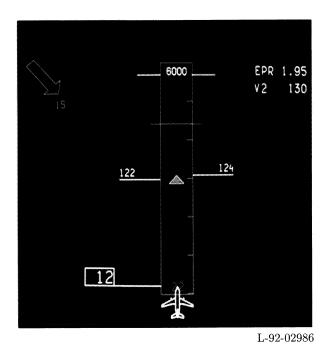
Figure 11. TOPMS display when ready to begin takeoff.

similar to the graphic shown in figure 11 will appear. This graphic shows where V_1 of 122 knots and V_R of 124 knots should occur with respect to the airplane initial position on the runway. (For viewing clarity, the computed airplane position is depicted by the nose of the airplane graphic.) The length of the assigned runway (6000 ft) and the point where the takeoff roll will start have been entered; the algorithm has scaled the corresponding runway graphic

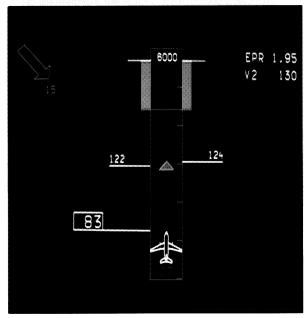
L-92-02987

Normal takeoff roll. Figure 12 shows a typical TOPMS display during a normal takeoff roll on a 6000-ft-long runway. The airplane is traveling at a CAS of 83 knots. Note that the top ends of both EPR bars match their target levels (1.95) and that the V_R triangles have not separated. Under such conditions, the pilot can expect to reach V_R approximately halfway down the runway and the monitoring tasks would primarily be to keep track of airspeed and occasionally to glance at the V_R triangle The pilot can monitor airspeed and EPR bars. by watching the numerals in the speed box or by observing the closure of the moving CAS line on the near-stationary V_1 line. The pilot can also keep the analog display of airspeed within peripheral vision range while continuing to focus on the real-world runway scene.

Figure 12. TOPMS display when normal takeoff under way.

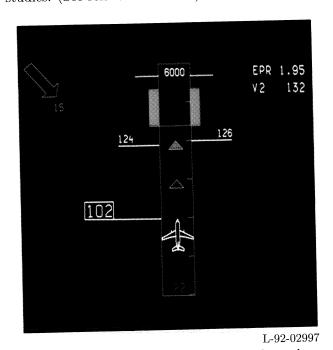
Low-throttle takeoff roll. Figure 13 shows the TOPMS display for a situation in which the throttles were not advanced to the nominal position for attaining scheduled EPR (selected during pretakeoff by the algorithm from the database programmed from the TSRV flight manual). The shaded triangle has moved forward nearly 1000 ft from its initial location where it had been superimposed on the unshaded triangle. If the shaded triangle remains stationary at this new position, it signifies that thrust is correct for the actual throttle setting and no acceleration error exists. The throttles can be advanced to reduce this separation or the takeoff roll can be continued at reduced thrust with the expectation of a satisfactory takeoff. In alternate form, the algorithm could respond to the low-throttle settings with error condition graphics; this was not the choice in any of the TOPMS studies. (See refs. 7–10 and 12.)

Figure 13. TOPMS display with throttle set lower than scheduled.

- 2. If no engine has failed and the throttles have a lower than nominal setting (fig. 13), the EPR bars will accordingly stop short of their target mark, but they will not change color. The shaded triangle will also move noticeably forward; no SAF will be displayed unless the triangle moves beyond the GRLL.

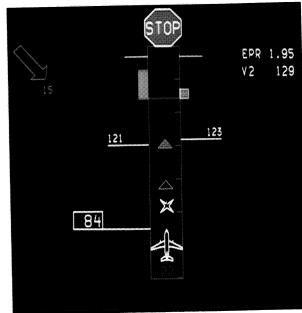
L-92-03001

Engine failure during low-throttle takeoff roll. If an engine fails during a reduced-thrust takeoff-roll situation, the TOPMS display will be similar to the graphic shown in figure 14. An engine failure is declared by the algorithm when the engine EPR has degraded by more than a specified amount (10 percent in this study) from the value normally

Figure 14. TOPMS display for engine failure during reduced-throttle takeoff.

produced for the measured throttle position. For the situation in figure 14, the under-advanced throttles are commanding both engines to produce EPR's of approximately 1.7 rather than the scheduled 1.95. The left engine is apparently producing the commanded EPR value of 1.7; however, the EPR bar for the failed right engine is clearly less than 90 percent of the length of the apparently correct left EPR bar and has turned red. Concurrently, a red SAF (STOP sign) and a predicted stop point \times have appeared and the V_R triangles have separated by more than 1000 ft. If the performance of the faulty engine degrades further, the shaded triangle will continue to advance toward the GRLL. At this stage, takeoff is still a viable option; however, NO-GO is the control action recommended by the TOPMS before airplane speed increases further and the remaining runway distance becomes more marginal.

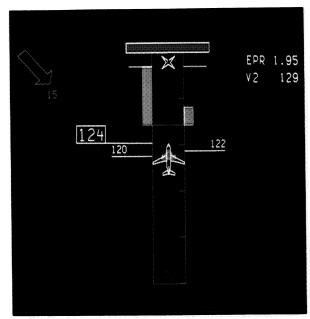
L-92-03000

Engine failure at high speed. If an engine failure occurs near V_1 on a relatively short runway, as shown in figure 15, the SAF is displayed as a large green rectangle at the end of the runway graphic. This symbol advises the pilot that the best option is to continue with the takeoff because a maximum-braking stop would likely terminate near or beyond the end of the runway pavement. (See the \times in fig. 15.) Also, note in figure 15 that the current CAS = 124 knots is greater than the decision speed $V_1 = 120$ knots, which is an overriding condition that warrants continuation of the takeoff.

Figure 15. TOPMS display for engine failure near V_1 on short runway.

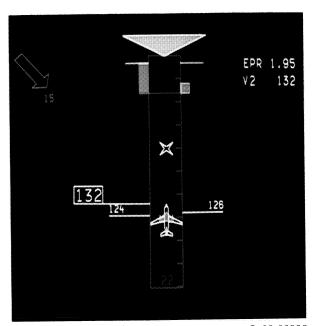
L-92-02996

Figure 16. TOPMS display for engine failure after reaching V_1 on very long runway.

If a similar situation were encountered on a very long runway, the TOPMS would exhibit a blinking triangular GO/NO-GO SAF like the one shown in figure 16. The blinking amber SAF signifies that an engine has failed at or above V_1 and that the two viable control options include continuing the takeoff as currently required by regulations (ref. 11)

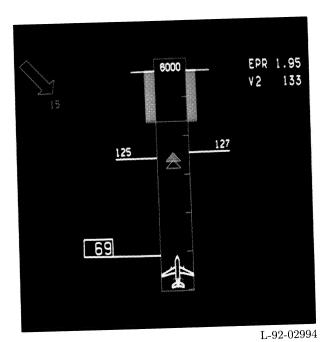
Figure 17. TOPMS display with acceptable acceleration deficiency.

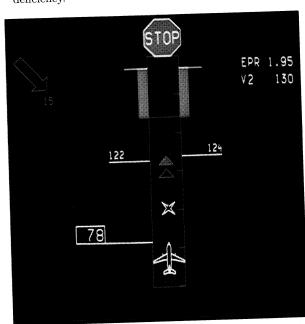
L-92-02988

Figure 18. TOPMS display with unacceptable acceleration performance.

- 7. Ten takeoff rolls were made with the spoilers fully deployed to create excess drag as airplane speed increased. In response, the shaded triangle was observed to creep forward until the resulting acceleration error tripped the abort SAF. (See fig. 18.)

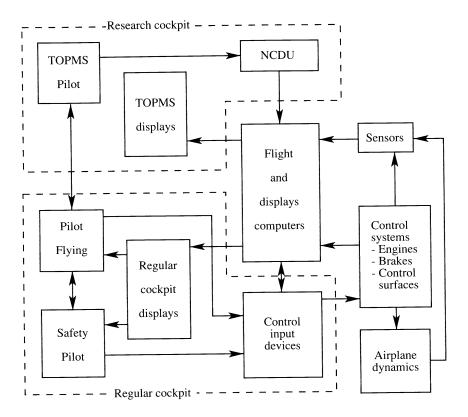
As indicated in figure 21, the TOPMS flight-test crew consisted of a Pilot Flying who controlled the airplane from the left seat of the TSRV regular flight deck, a TOPMS Pilot who monitored the TOPMS displays in the research flight deck and communicated with the Pilot Flying by the intercom, and a Safety Pilot who occupied the right seat in the TSRV regular flight deck and participated minimally in the

Figure 21. Functional block diagram of test system.

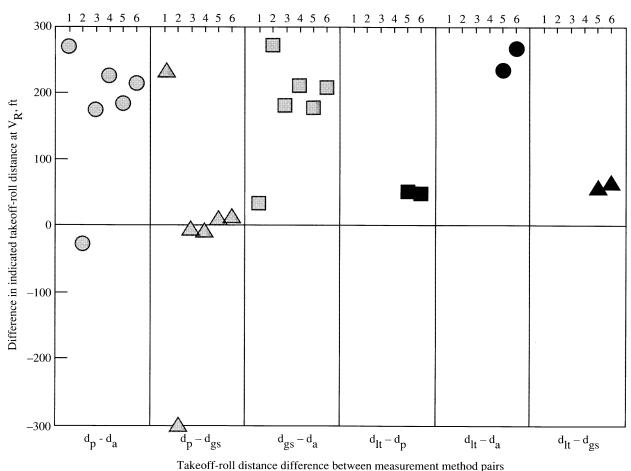
Figure 27. Comparison of laser-tracker-measured and TOPMS-computed positions of TSRV at V_B.

A comparison of the computed and measured position data is shown in figures 27-29). In figure 27, six groups of incremental differences in takeoff-roll distances are shown across the bottom and the run numbers common to each group are indicated along the top. With the exception of run 2, the algorithm method 1 computed values of takeoff-roll distances d_a from the TSRV start points to the locations where its airspeed reached V_R were approximately 200 ft less than pretakeoff-roll-predicted distances d_p for nominal conditions. The magnitude of the differences corresponds roughly to two lengths of the TSRV or less than the distance it travels during the last second before reaching V_R . Part of the difference can be attributed to μ_r being updated from the 0.015 assumed nominal value to values ranging from 0.020 to 0.030. Also, the wind inputs were adjusted 2-3 knots upward in all but run 2, where no change occurred. In runs 3–6, the method 2 computations of distance traveled for the TSRV to reach V_R (d_{qs}) closely agreed with pretakeoff predictions of V_R positions; method 1 computations showed only fair agreement.
